Fire in Haunted Castle Kills Eight

JOHN BOUCHARD

INVESTIGATION REPORT: HAUNTED CASTLE FIRE

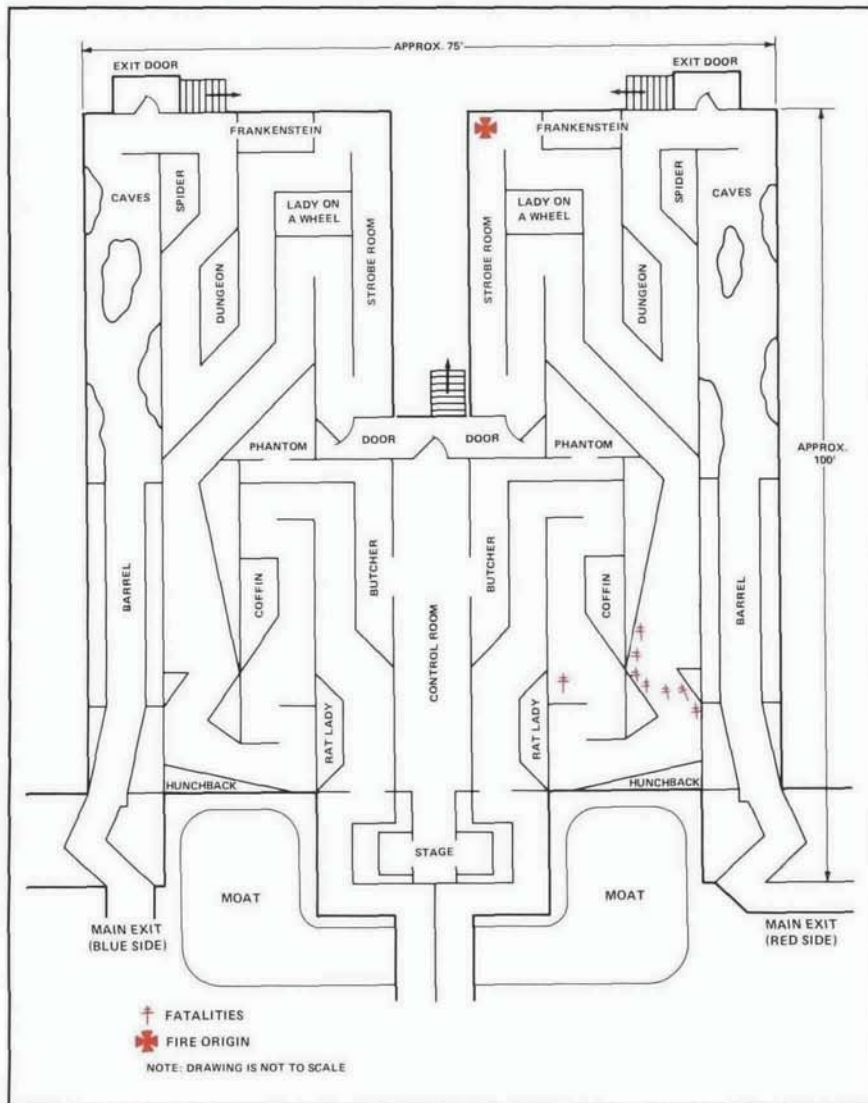
Figure 1. Floor plan of Haunted Castle. Shaded area indicates the Red Side, which was open on the day of the fire.

According to the Ocean County Coroner's office, eight young adults, who ranged in age from 15 to 19, died as a result of smoke inhalation and carbon monoxide poisoning. Seven of the victims were found in the corridor near the hunchback display; the eighth victim was found in the vicinity of the coffin display (see Figure 1).

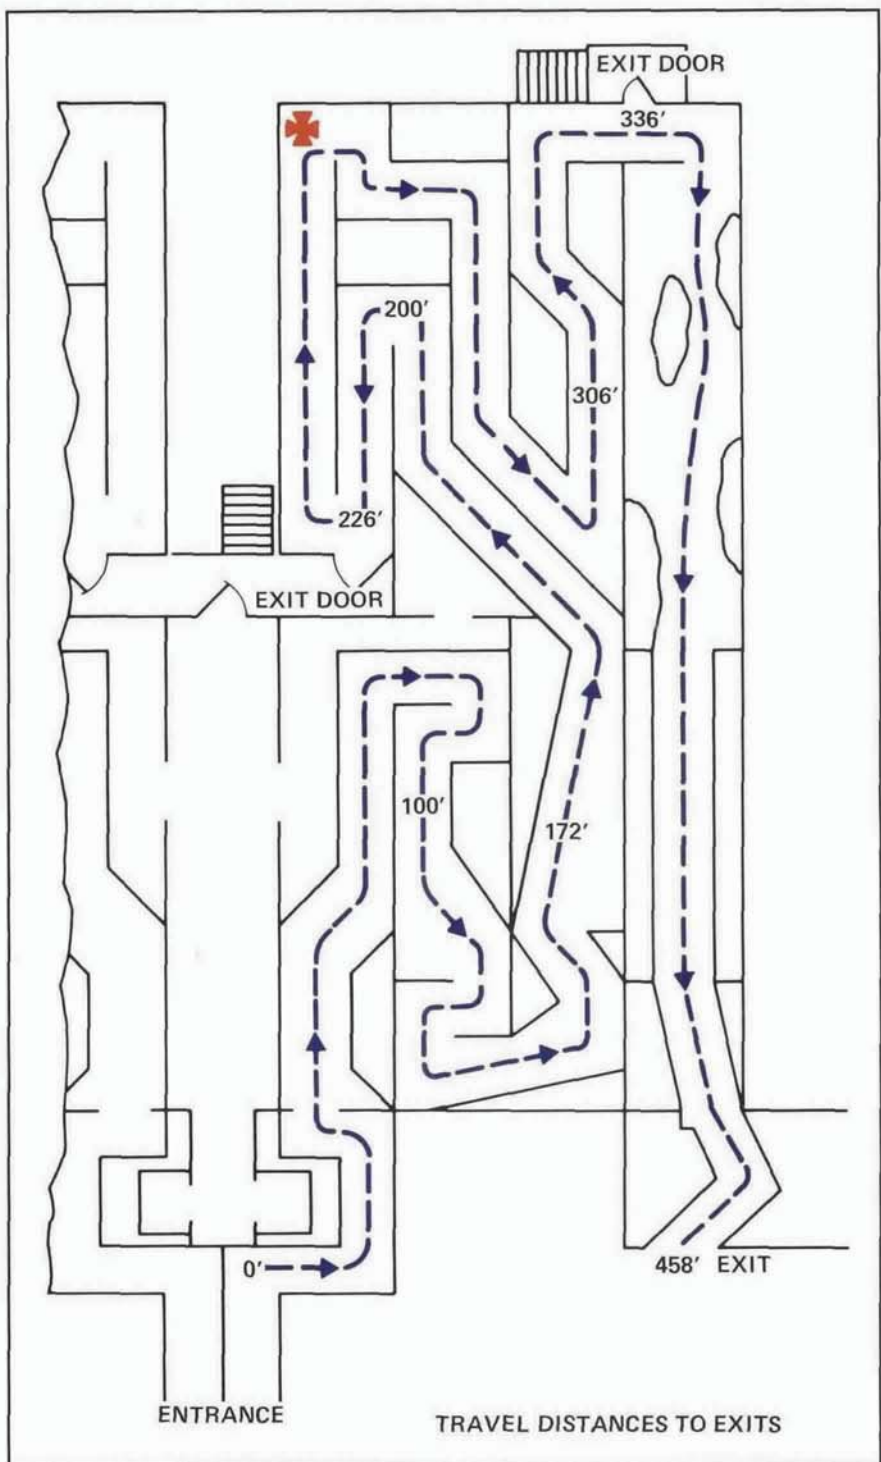
Figure 2. Travel distances to exits in feet.

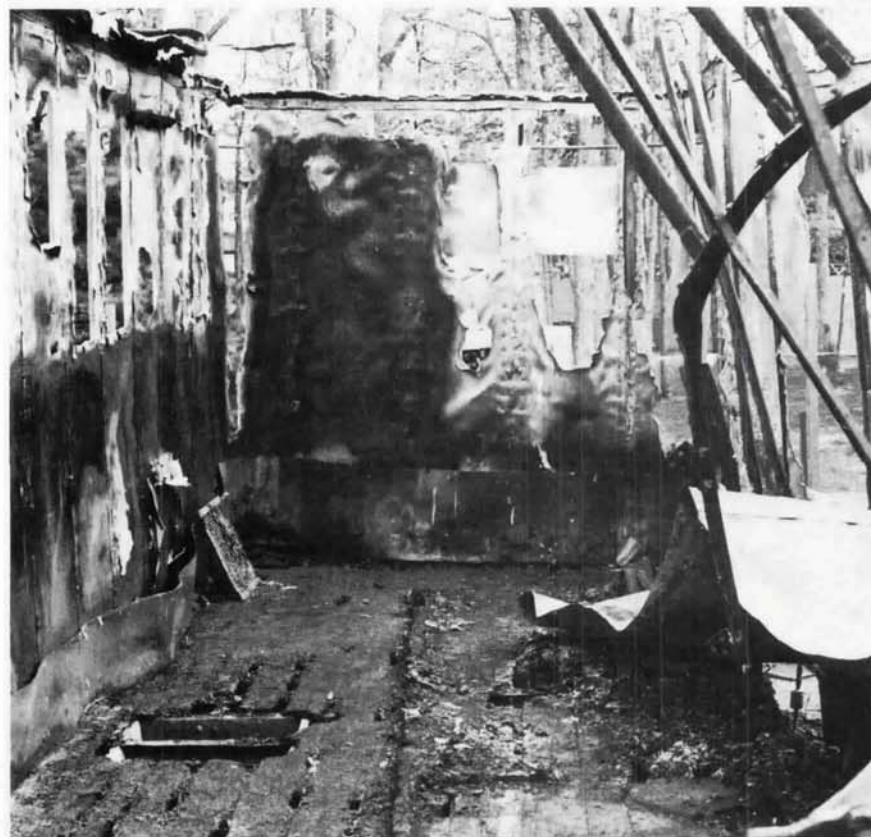
Photo 3. Area of fire origin. A synthetic foam pad was located over the darkened area in the left center of the photograph.

Ocean County Fire Marshal's office, and the New Jersey State Police determined that the cause of the fire was accidental ignition of polyurethane foam padding on the wall of the strobe room.

Once ignited, the wall-mounted polyurethane foam pad burned rapidly and spread the fire vertically in the trailer corner. Fire spread down the strobe room corridor, further fueled by the plywood construction of the ceiling, floor, and walls. Once the fire had spread through the corridor, it extended past the Phantom of the Opera area and to other portions of the Haunted Castle.
