Commonwealth of
Massachusetts
Department of Public Safety
ACCIDENT REPORT

*Six Flags – New England, Agawam, MA
Superman Roller Coaster*

ACCIDENT / INCIDENT FACT SHEET

ACCIDENT INVESTIGATION

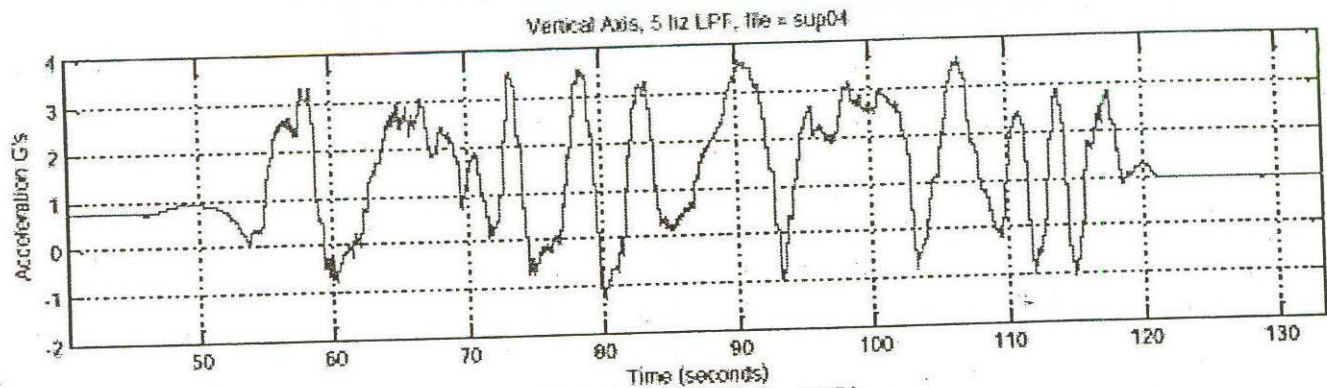
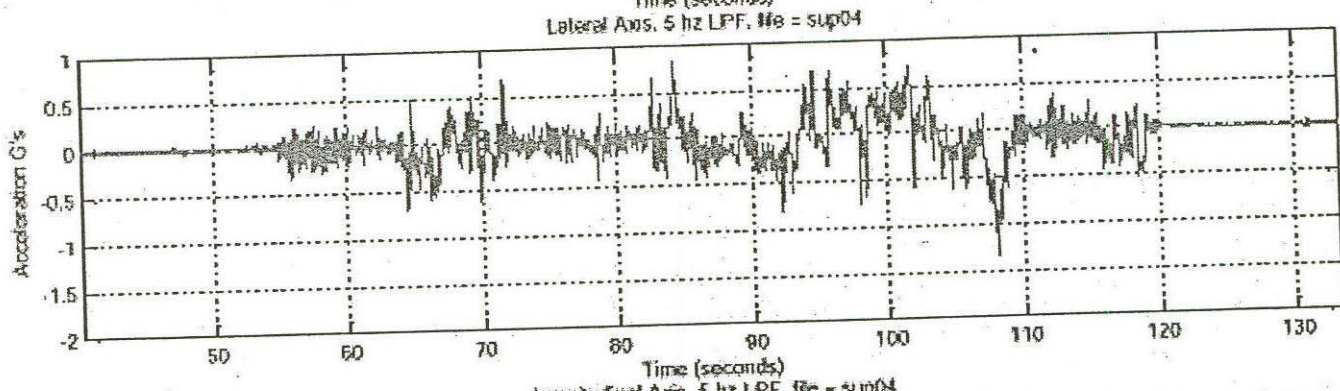
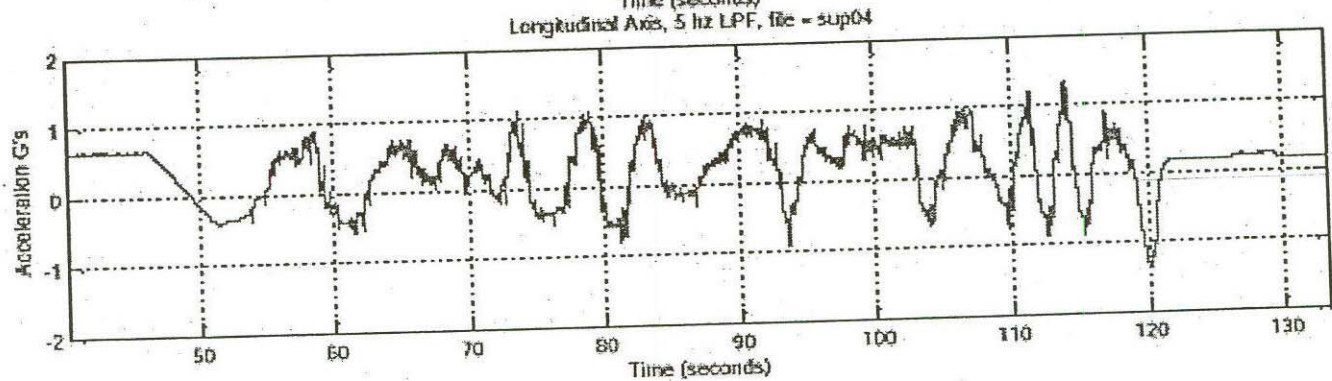
Superman Coaster - Acceleration Data

“came up too much” and he began to fall out of the left side. Both Mr. Menard and Ms. Thomas attempted to hold onto _____ as the ride came into the last turn, however the forces applied on _____; body were too great for them to hold on and his body was quickly thrown from the ride. The maximum peak instantaneous negative value in that section of the ride was -0.4 G, and the maximum peak instantaneous positive value in that section of the ride was +2.9 G according to ride accelerometer data.

This information represents forces measured in the front left seat of a fully loaded train along the entire circuit.

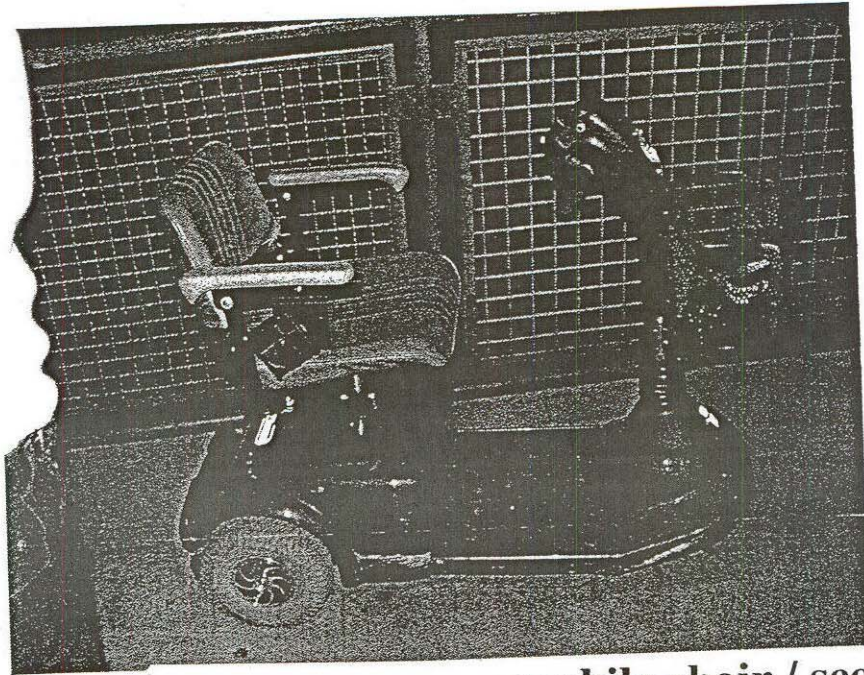
Photo #1 - s mobile chair / scooter

Upon investigation it appears that the victim, _____ arrived at the Superman Coaster ride on a scooter/mobile chair (see photo#1). Several ride attendants were aware of _____ and his scooter/mobile chair and made reasonable accommodations to allow him to park his scooter where he then walked to the front seat of the coaster. Based on witness testimony, it appears that _____ was guided into his seat by a ride attendant, and entered the ride by himself. The ride attendant was "going to sit him in the 2nd or 3rd car" however due to his larger size, the attendant sat him in the front seat because "those cars have a larger seatbelt so he would not have any problems buckling". It was observed, after the accident, that the _____ s seat belt was still connected and latched. The position of the latching mechanism was pulled between the seat, and the side restraint. The ride photo (see photo #2) taken by an automatic camera on the coaster 10 to 20 seconds prior to the accident demonstrated that the seat belt was secured around

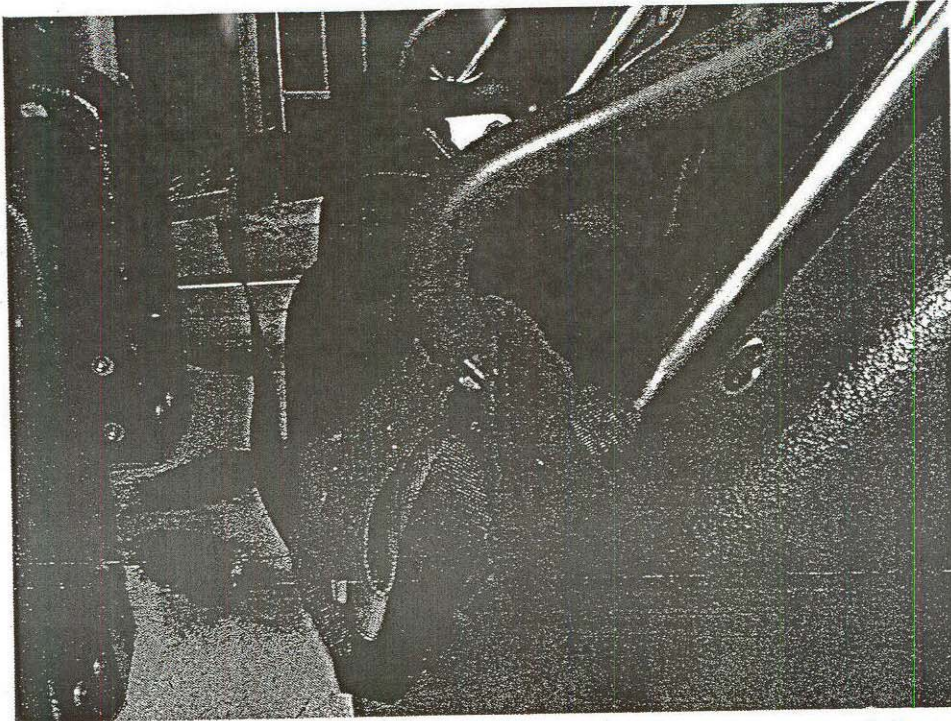
It appeared that upon his ejection from the seat, his foot caught the seatbelt and pulled

the belt into the final position (see attached photo #3). [redacted] s sock was also tangled with the seatbelt. One shoe was still in the car at the time of the investigation. This could have been knocked off by the lap restraint or the seat belt upon ejection. The second shoe was found on the ground near the point of ejection.

Photo #3 – Seat belt position following accident

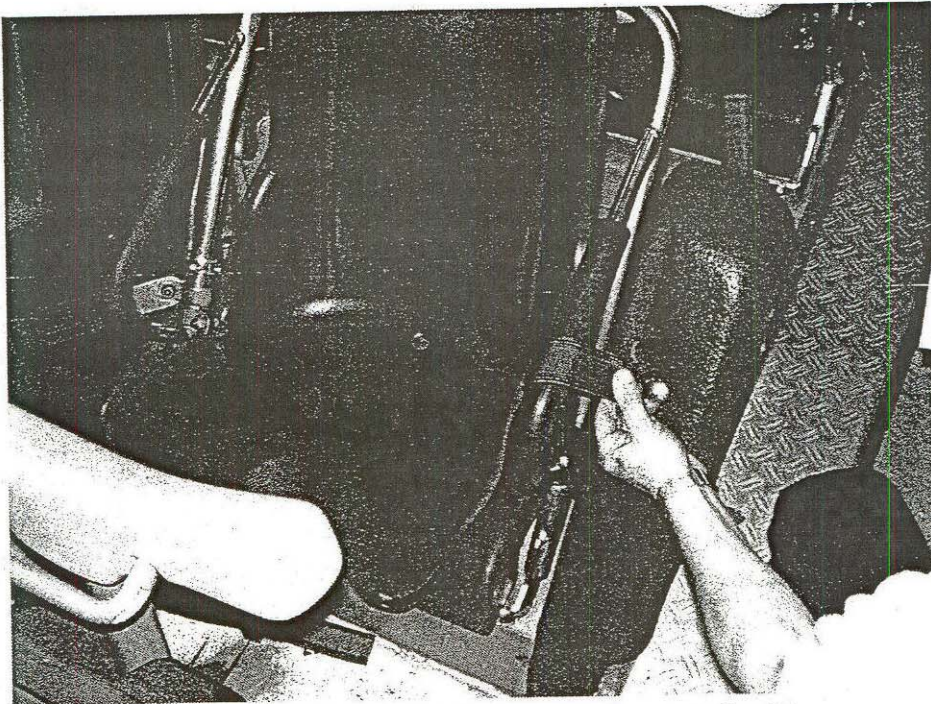
**Photo #3(a) – Photo of seat belt
(end of strap in position during ride)**

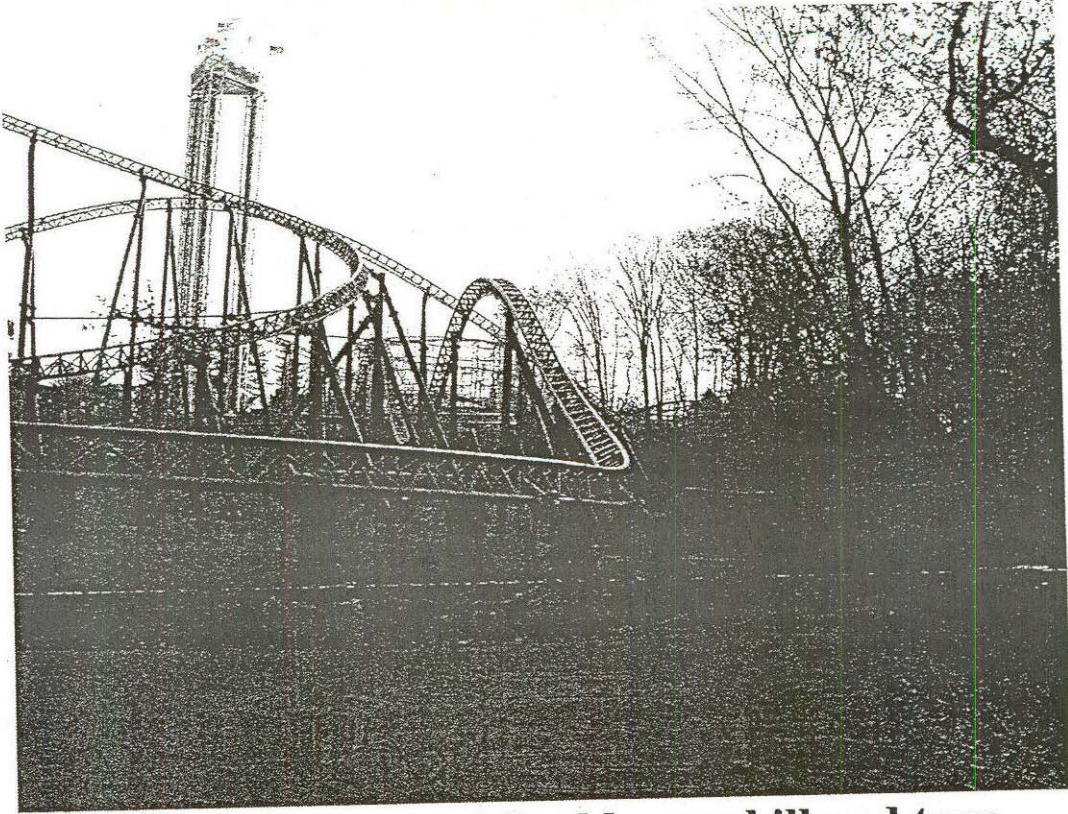
As _____ came out of his seat, the ride track begins to turn, which caused his body to move out of the car. As the coaster comes down the last bunny hill, the design of the track causes the coaster to pitch into the turn (see photo #4). At the point when _____ was exiting the coaster, and the coaster began to bank into the turn, his left hand landed on the left track of the coaster and the rear wheels of the 1st car struck his arm at his wrist, severing his hand. It should be noted that it is not physically possible for a hand to come in contact with the coaster wheels when a person is properly secured in the seat restraints. The severed hand struck a cross member on the coaster track before flying free from the track, landing 25 feet from the point of separation (see photo #5). Once _____ was clear of the coaster, his head and upper torso struck the #6 support column and he then traveled 31 feet (see photo #6) before striking the ground and traveling another 38 feet before striking a chain link fence bordering the property (see photo #7). At the time of this report, we do not have any conclusive evidence that _____ did or did not suffer any loss of consciousness prior to being ejected.

Photo #4 – Photo of final bunny hill and turn

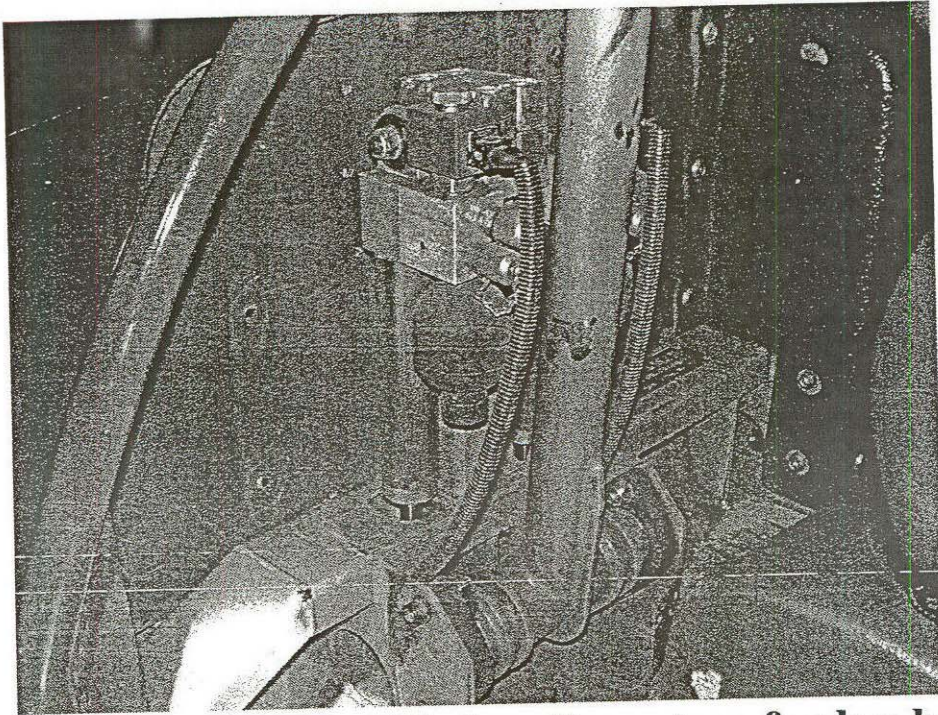
The hydraulic system of the "T" bar lap restraint was checked for proper function. The system appeared clean and free of leakage (see photo #8). The seatbelt system was also checked and mechanically functioned properly. Ride operational and maintenance logs were reviewed as well as the status of the Allen Bradley PLC, however, a printout of the PLC alarm log was not available at the time of the investigation (The system does not have a local printer set up), but has been requested.

Photo #8 – Photo of Hydraulic system for lap bar

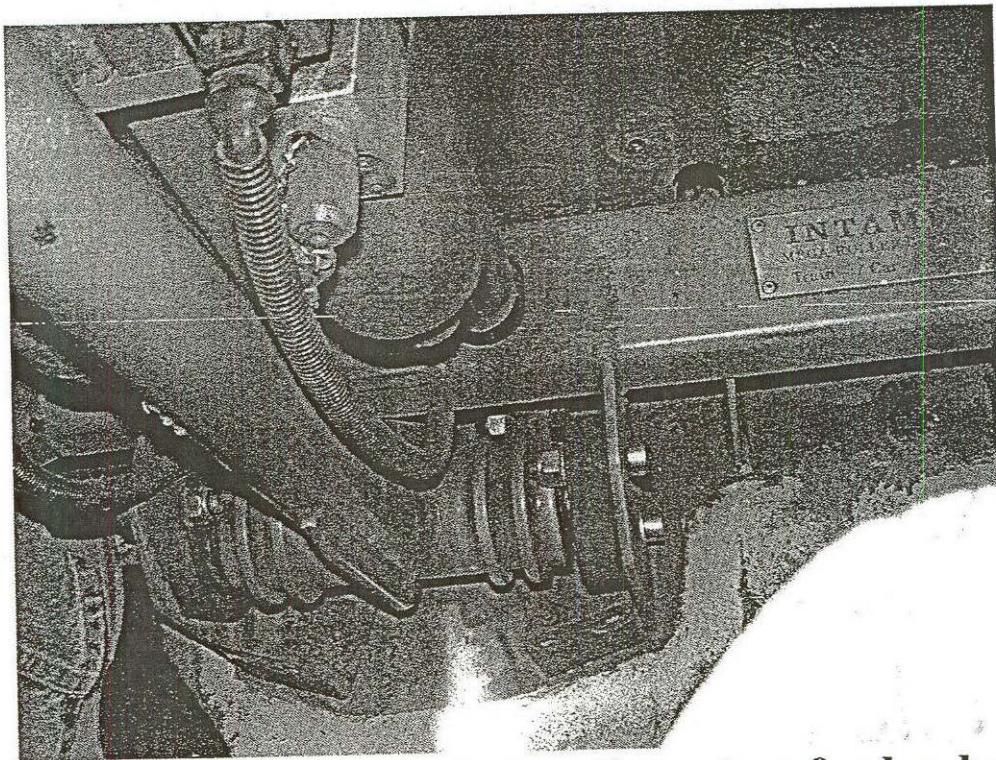
Photo #8a – Photo of Hydraulic system for lap bar

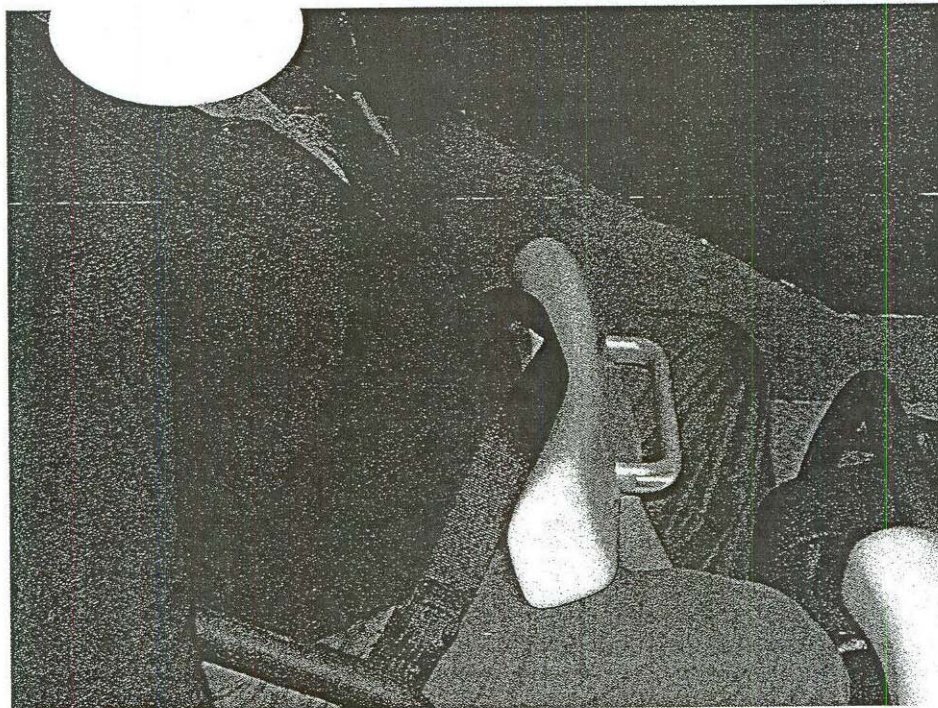
1. **Girth of the victim.** The girth of the victim's lower torso was incompatible with the "T" bar restraint. Based on photographic evidence, it appears that the victim's body configuration prevented the "T" bar restraint from being in a position that would adequately protect the patron from being ejected.

Photo #10 – Large adult used in testing “T” bar restraint
(Could not come free when “T” bar restraint broke vertical plan of front of seat)

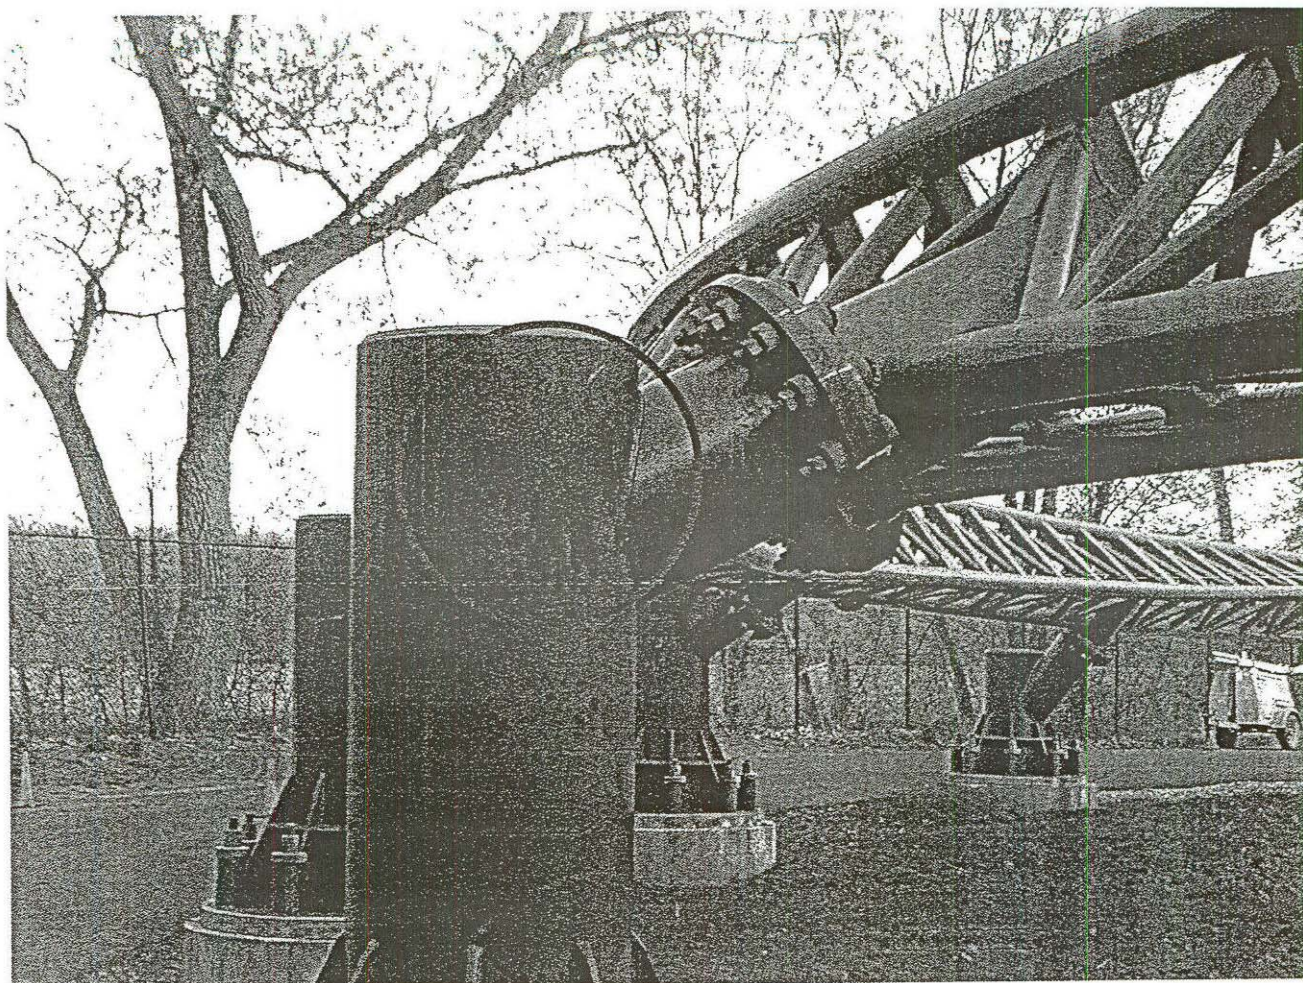
On the above date and location, at approximately 1500 hours, as the Superman Ride of Steel roller coaster was approaching the final turn in the cycle, _____ of _____ was ejected from the front row seat of the coaster. As a result of the ejection, he struck the #6 support column (as identified on sketch #1) and was fatally injured.

Photo #11 – Photo of location where victim struck #6 support column

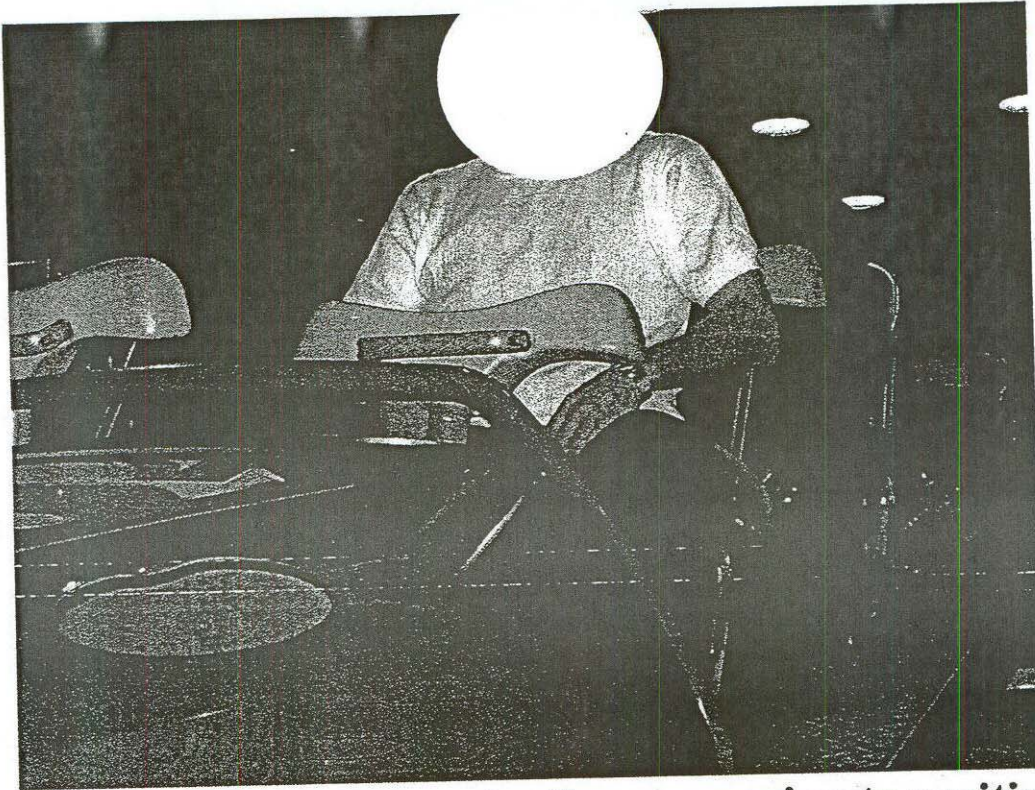
4. **Failure of ride attendant.** In order for the "T" bar restraint to work properly, it is necessary that the bar be positioned firm against the patron's upper thighs. In the case where individuals with large torso girth, the lower abdomen can interfere with the proper position of the "T" bar restraint. There was a failure of the ride attendant to properly identify that the restraints were inadequately applied. Had the ride attendant identified that the "T" bar lap restraint was not in a position necessary to protect the patron from ejection, the patron would have been removed from the ride.

**Photo #12 – Photo demonstrating approximate position of lap bar restraint in relation to average male.
(note excessive gap between restraint and legs)**

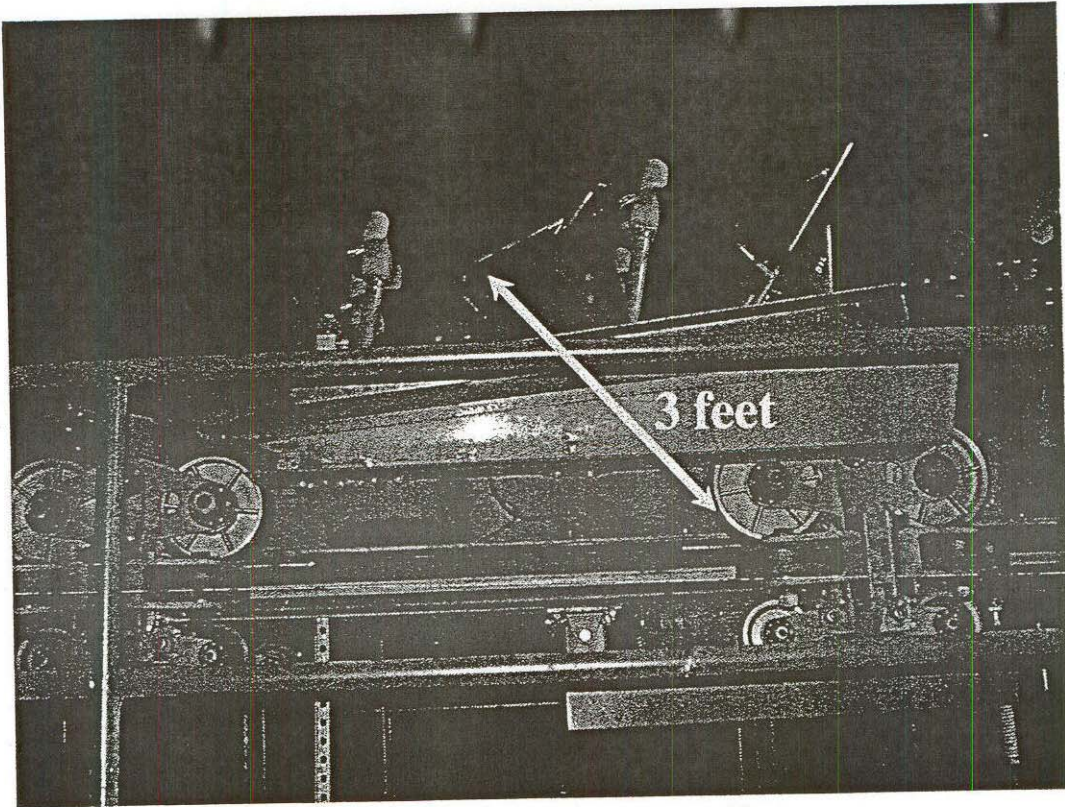
Photo #14 – Coaster Car
(Distance indicated from patron arm to rear wheels)
